Memorandum

Date: *August 15, 2014*

Subject: *Oversight Summary Report
CPG Oversight of RM 10.9 Removal Action
Lower Passaic River Restoration Project*

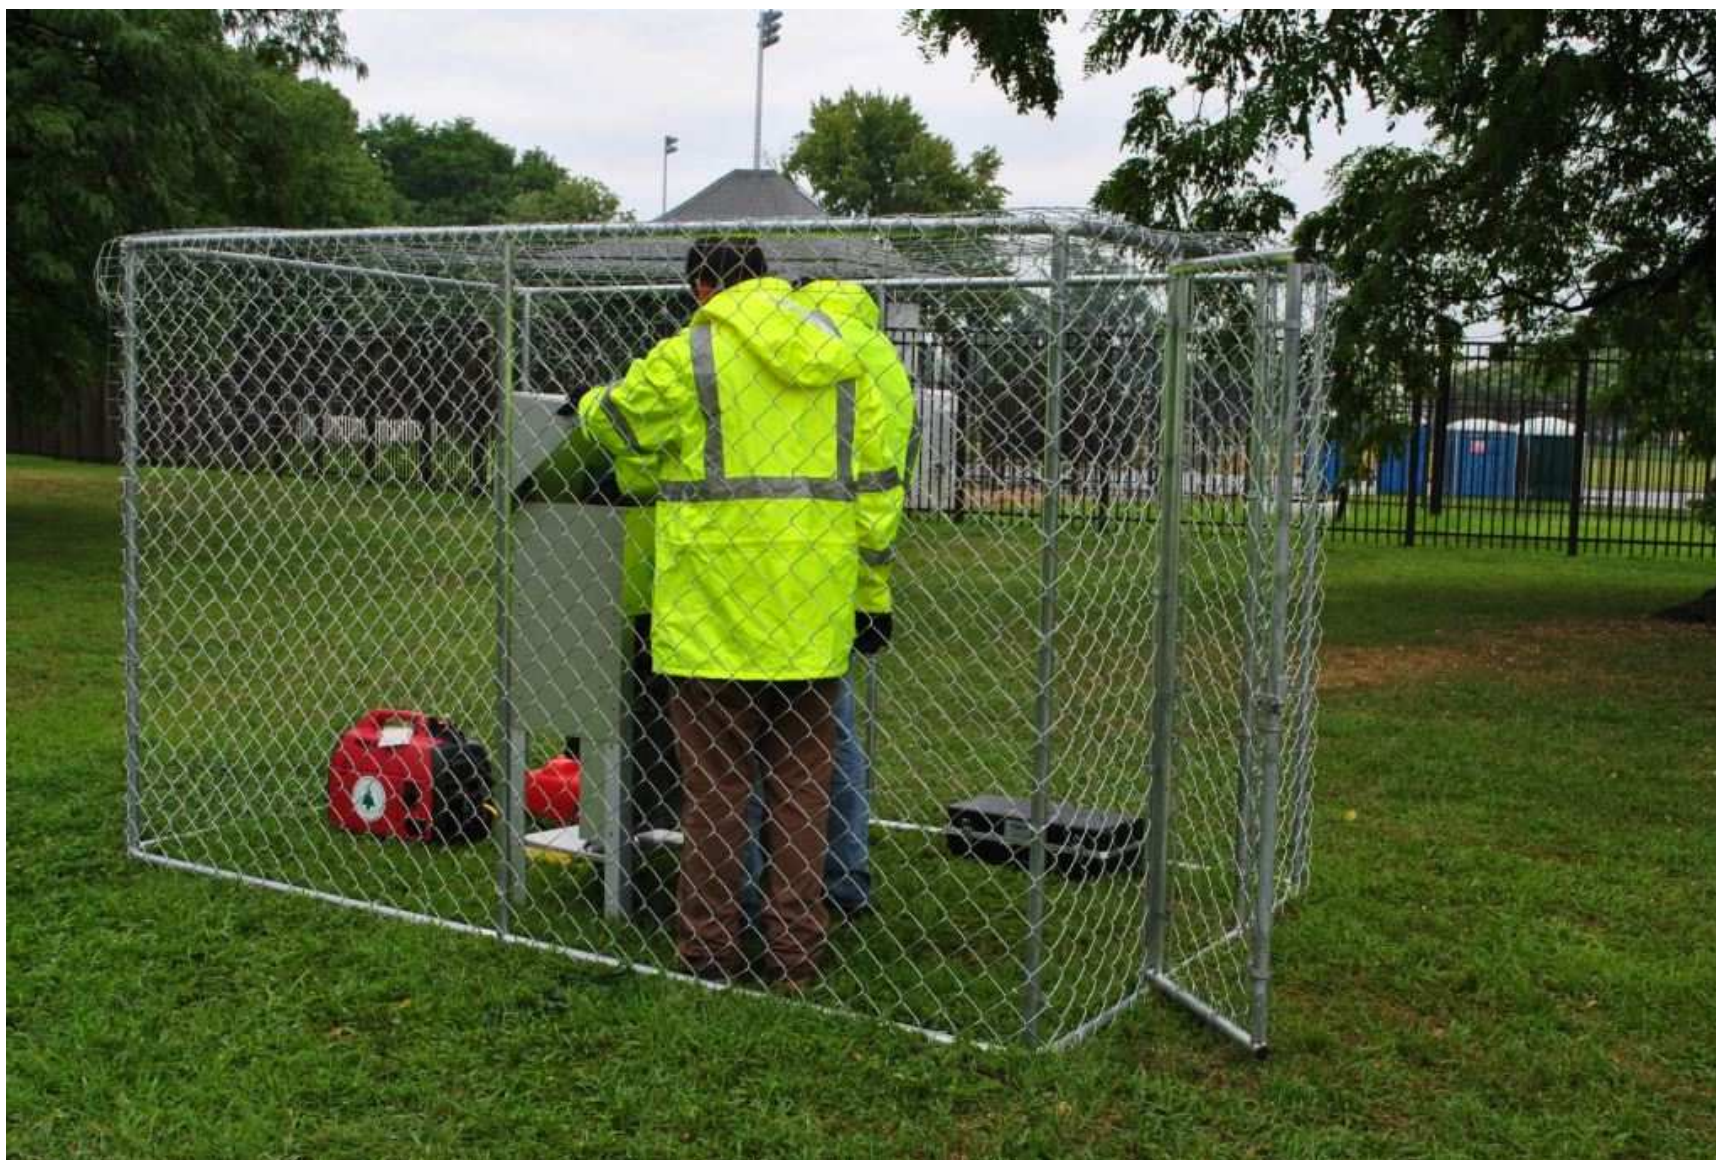
August 1 2013: CH2M Hill calibrated central air monitor

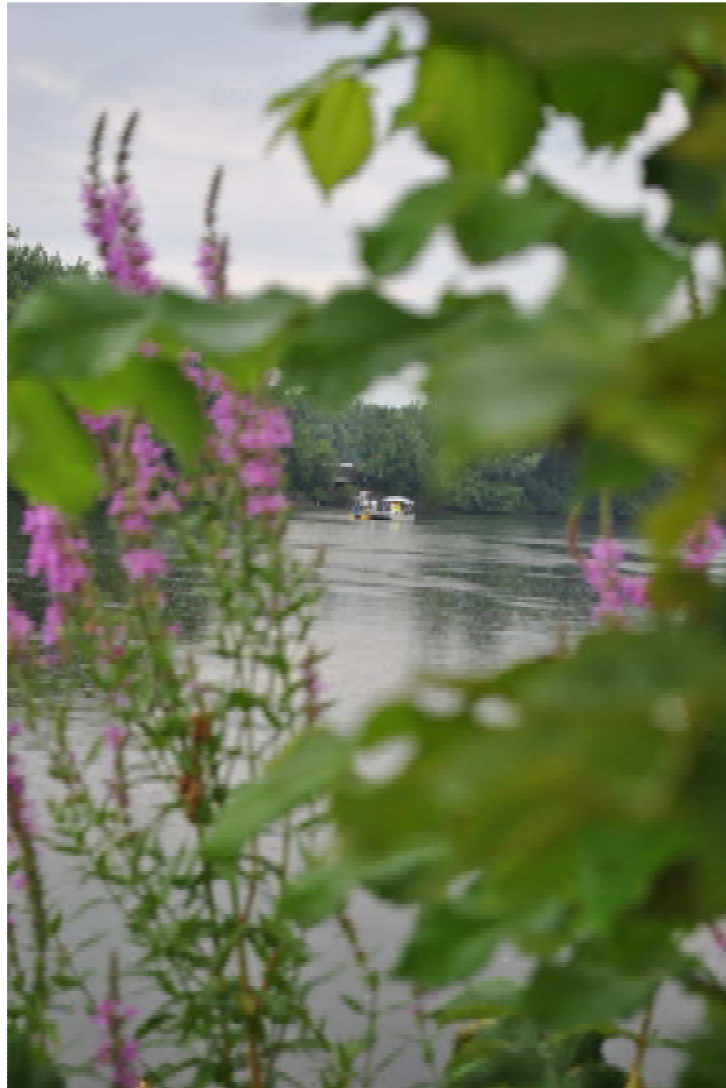
August 1 2013: Checking on in-river air unit

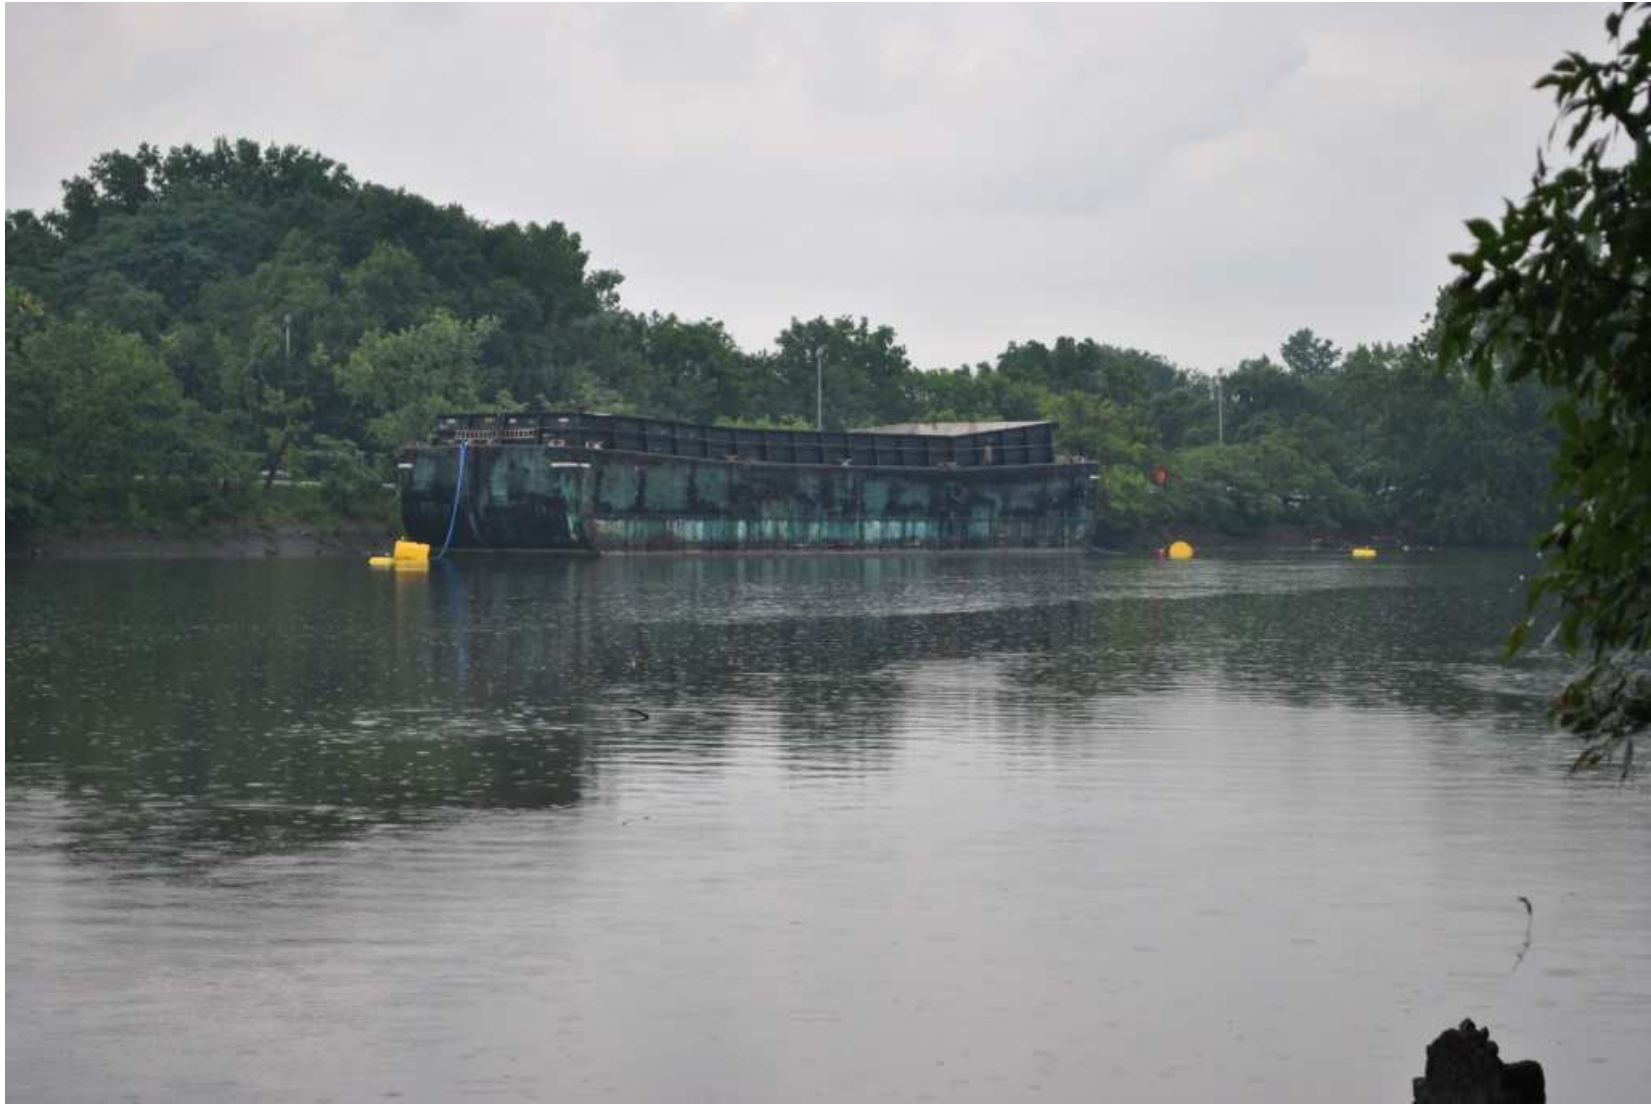
August 1 2013: Dump scow moored across from fire department boat launch

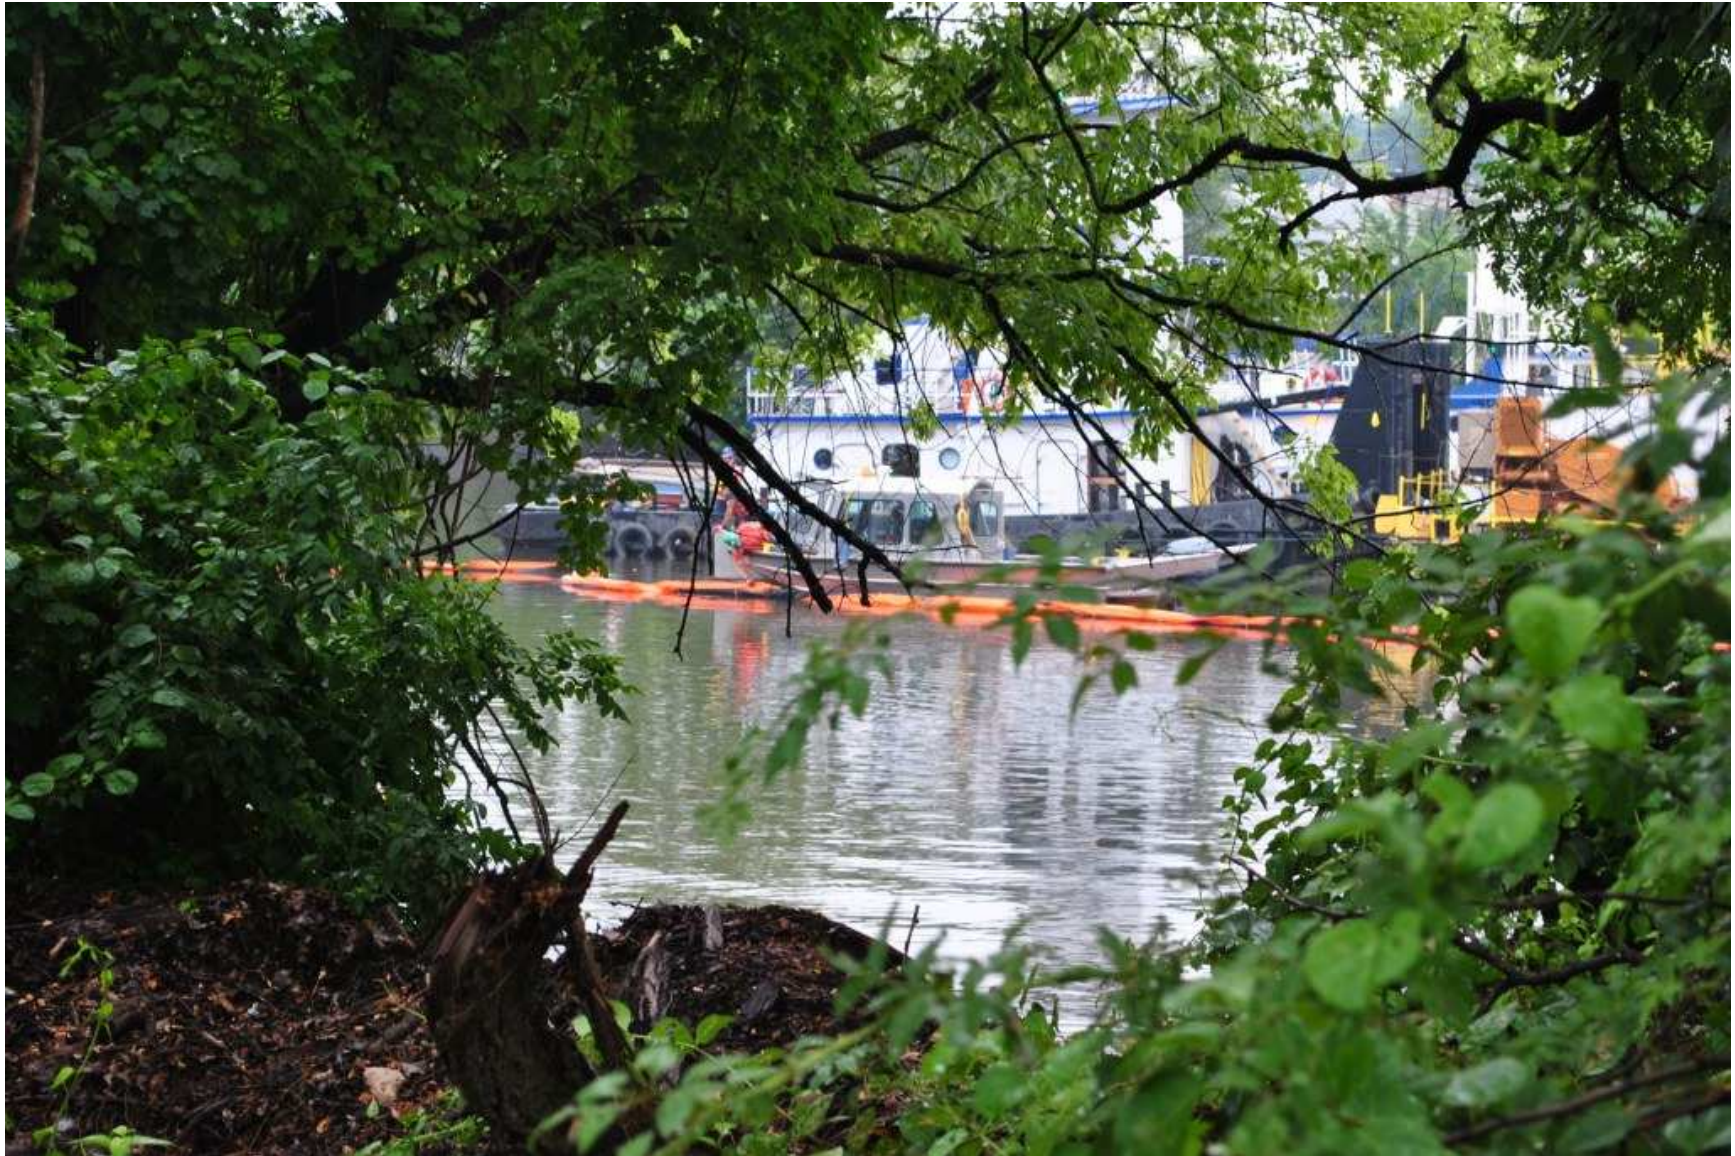
August 1 2013: GLDD deploying silt curtain

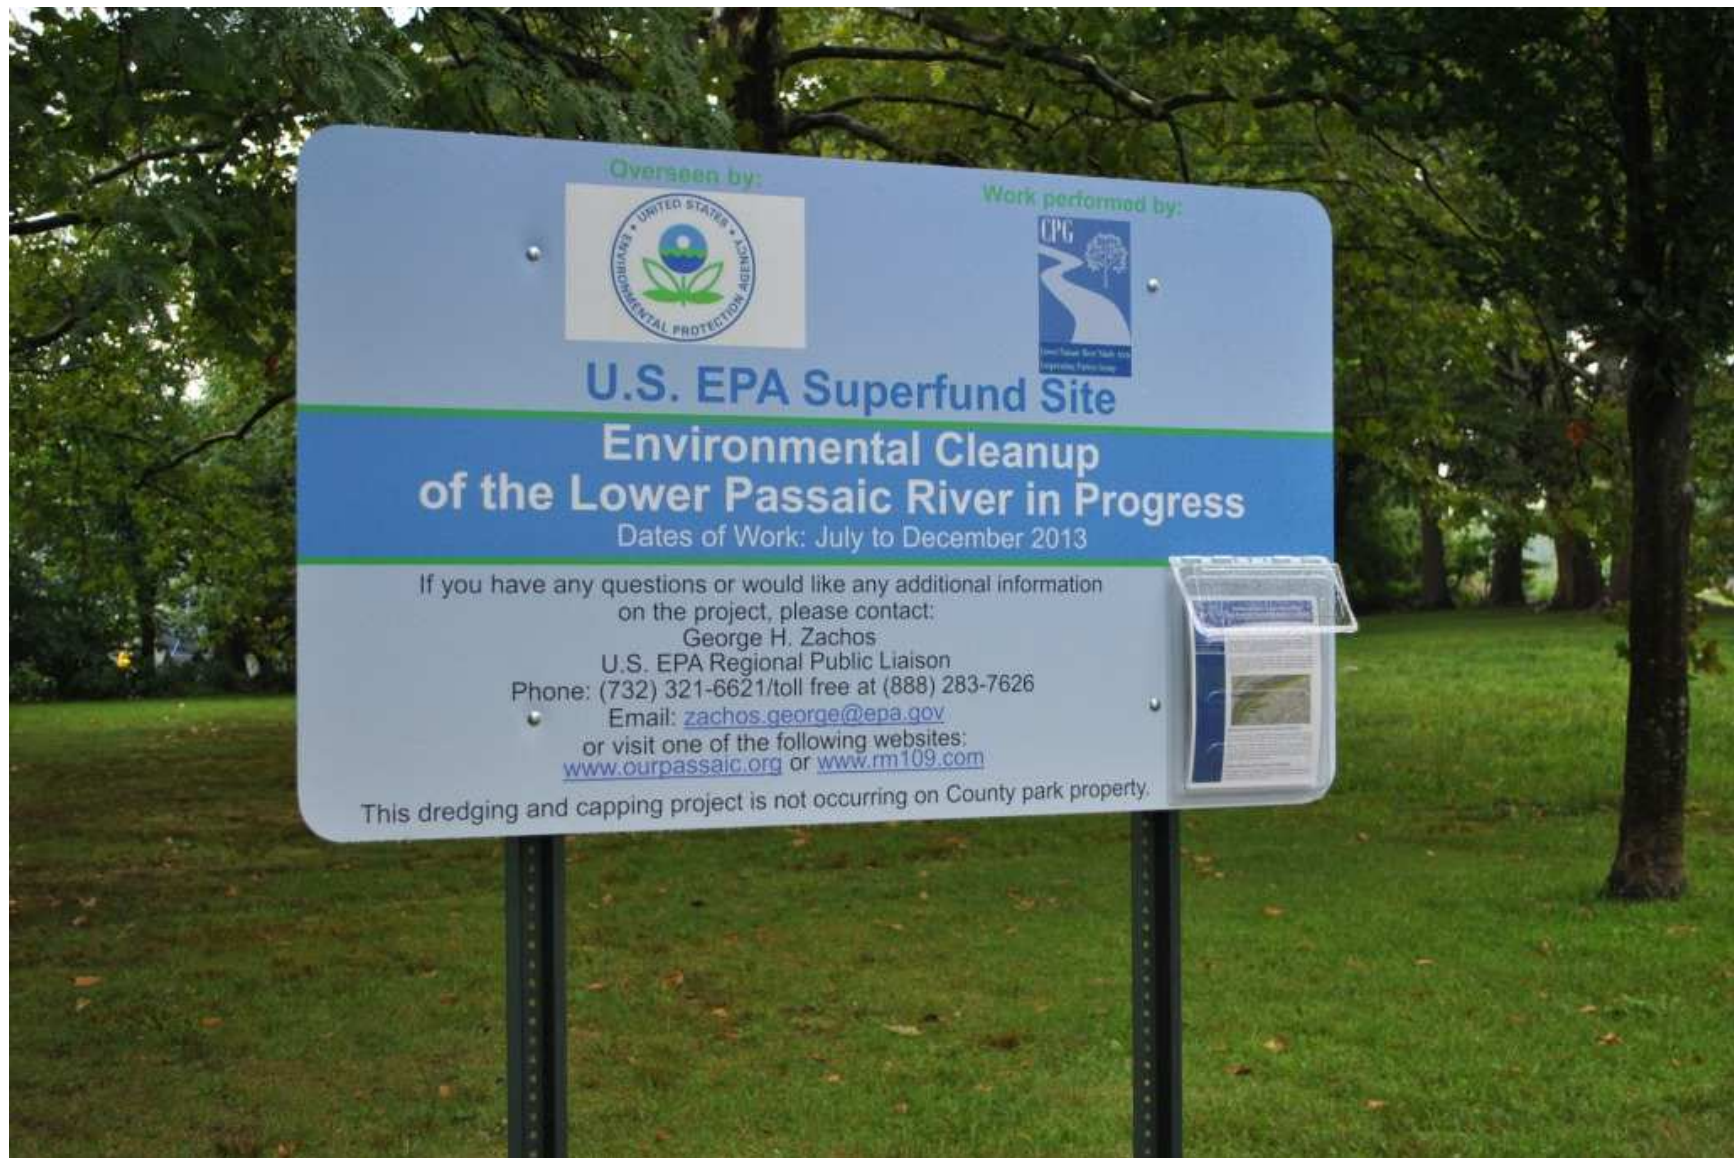
August 1 2013: In-park sign and informational packets

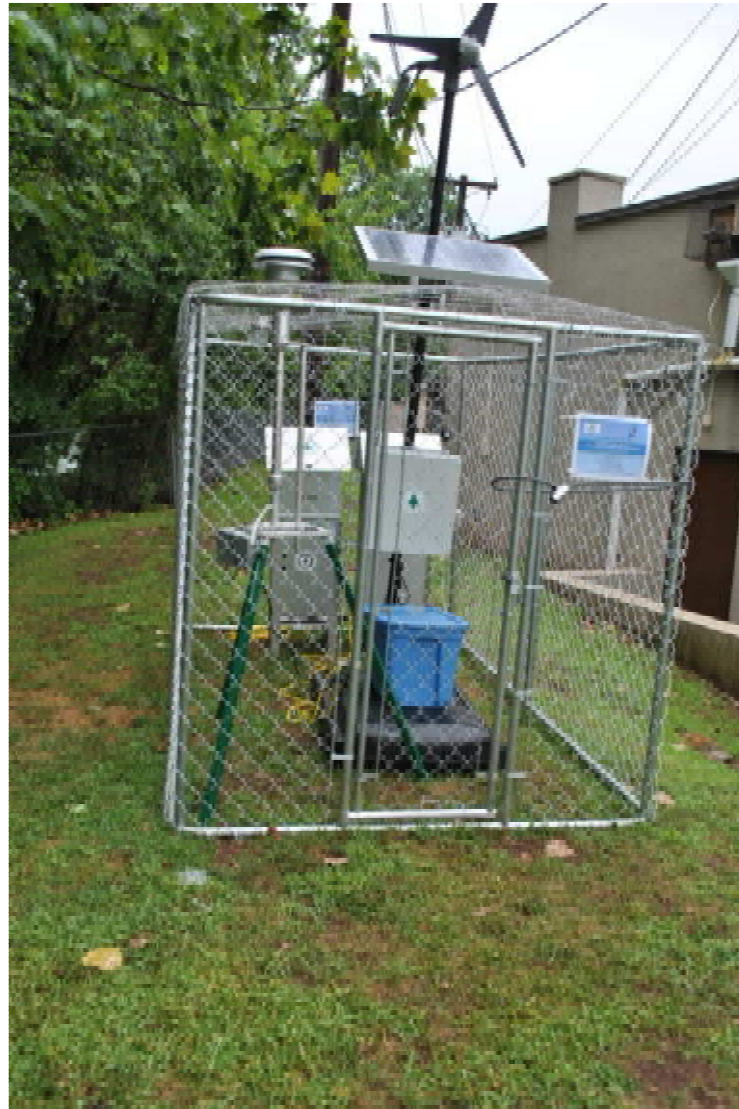
August 1 2013: Northern air monitor (near baseball field)

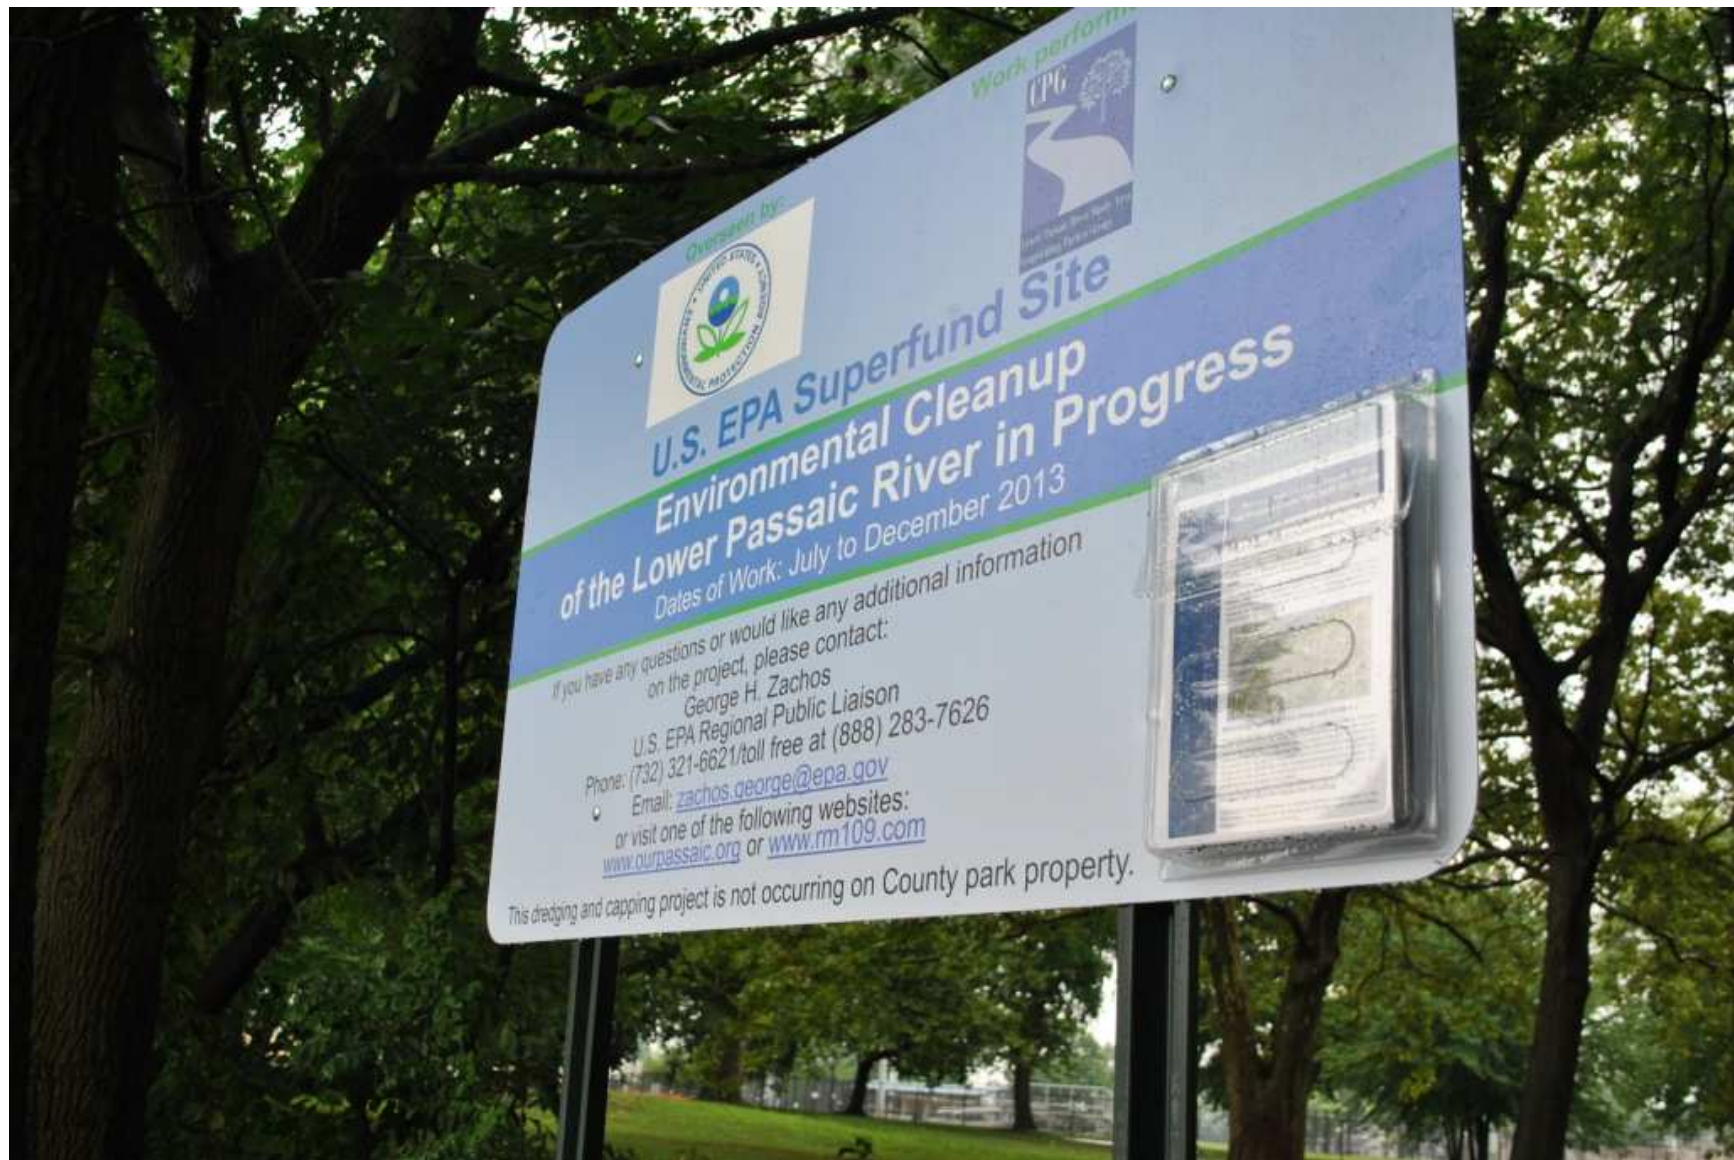
August 1 2013: Riverbank sign and informational packets

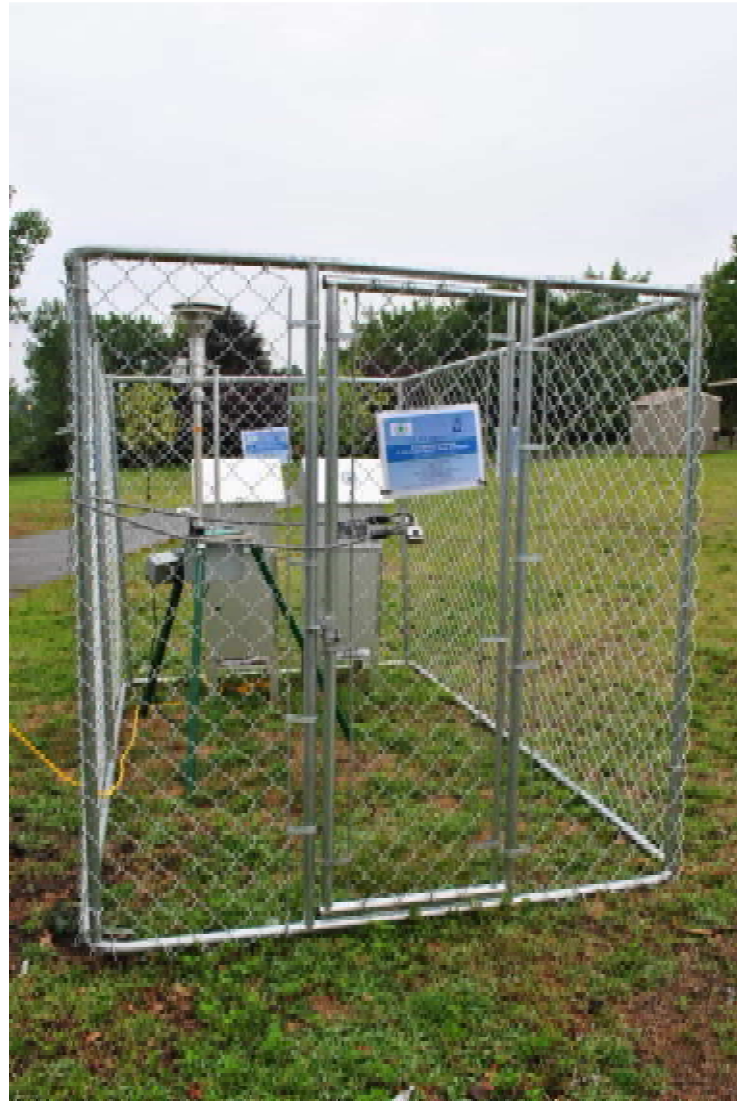
August 1 2013: Southern air monitoring station

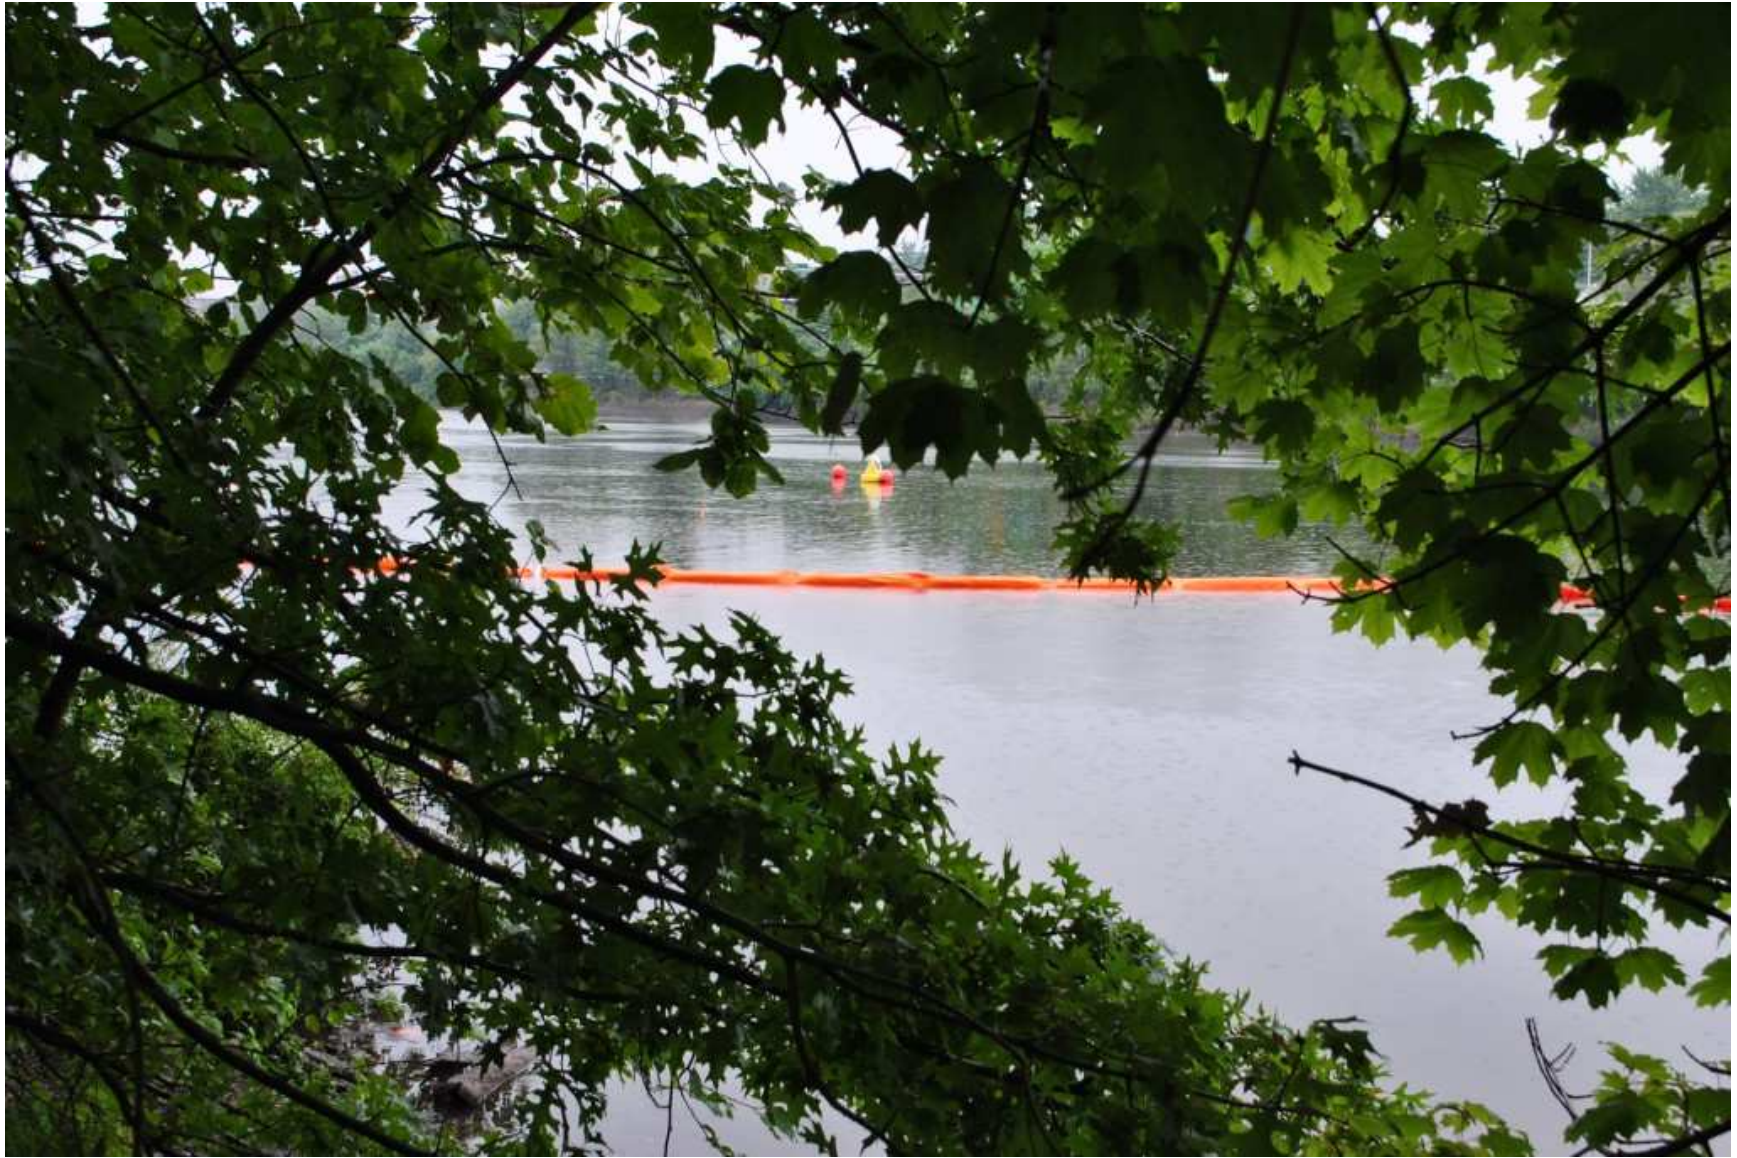
August 1 2013: Southern end of silt curtain

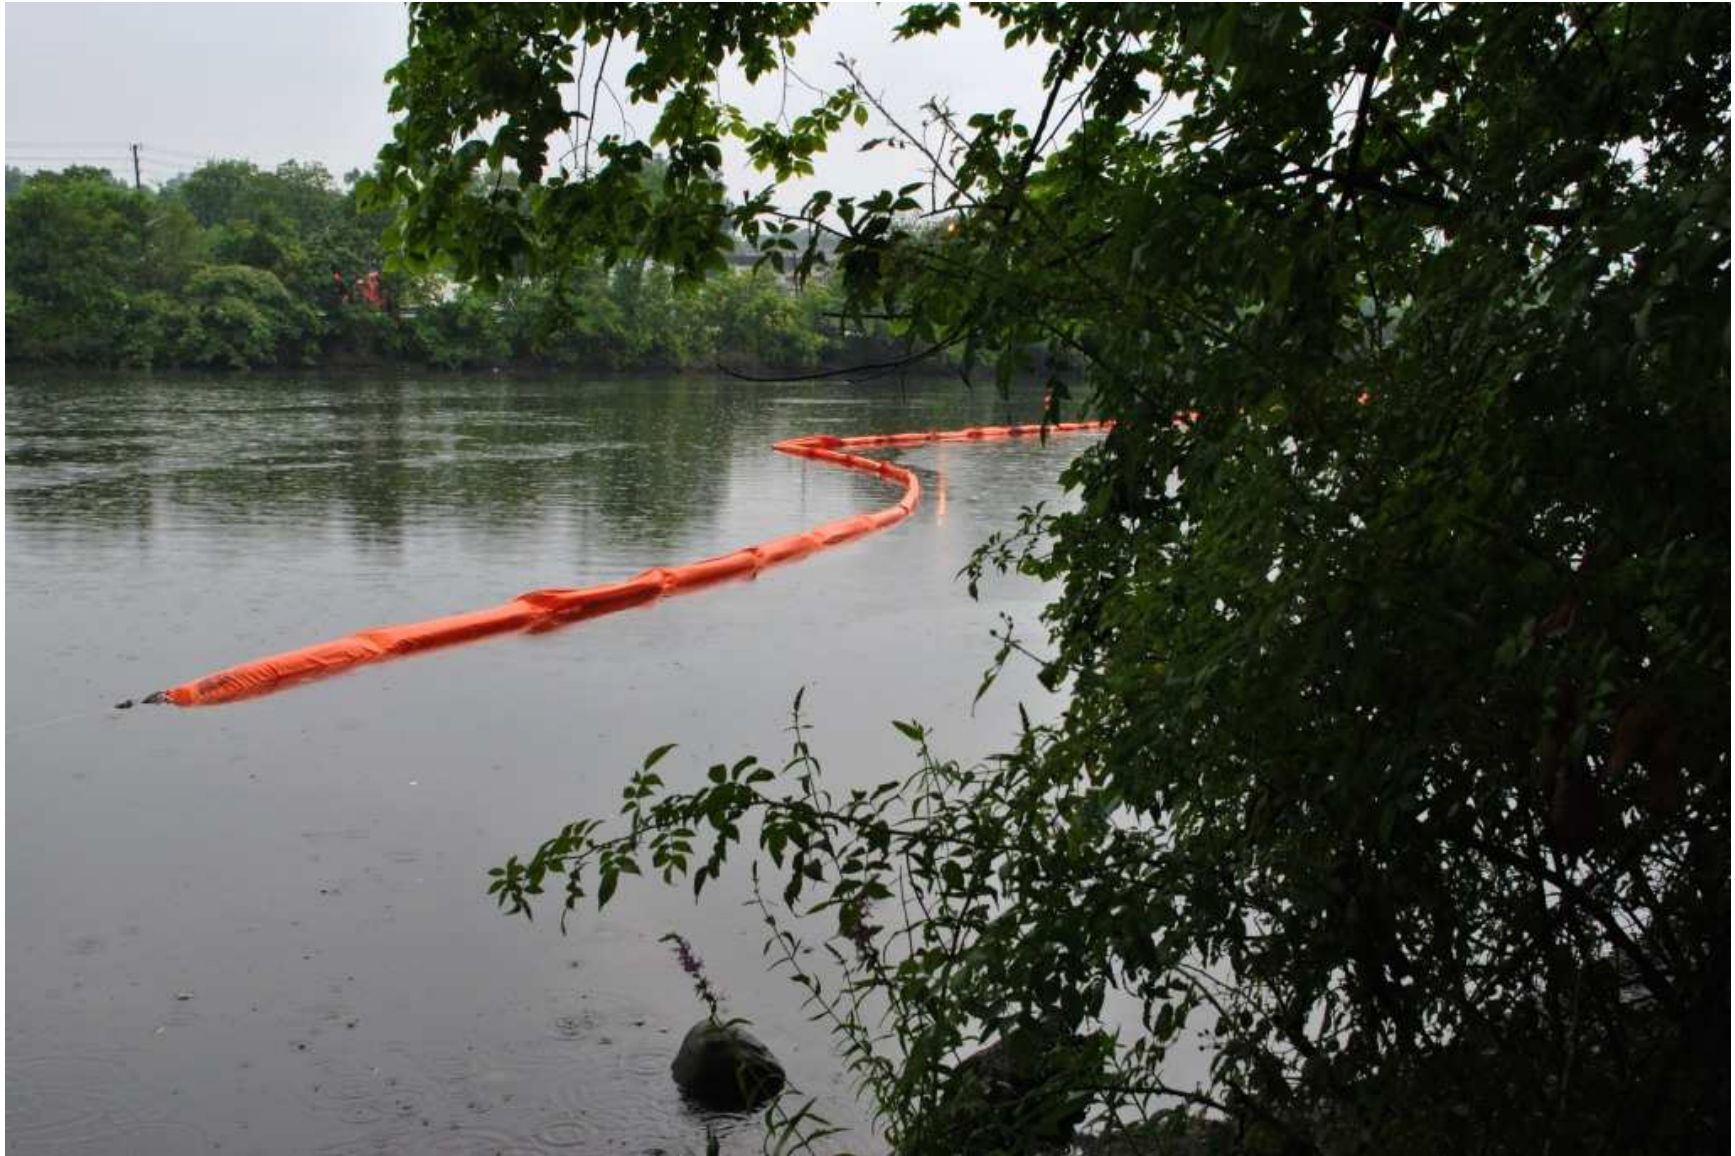
August 1 2013: Southern end of silt curtain deployed and anchored to shore

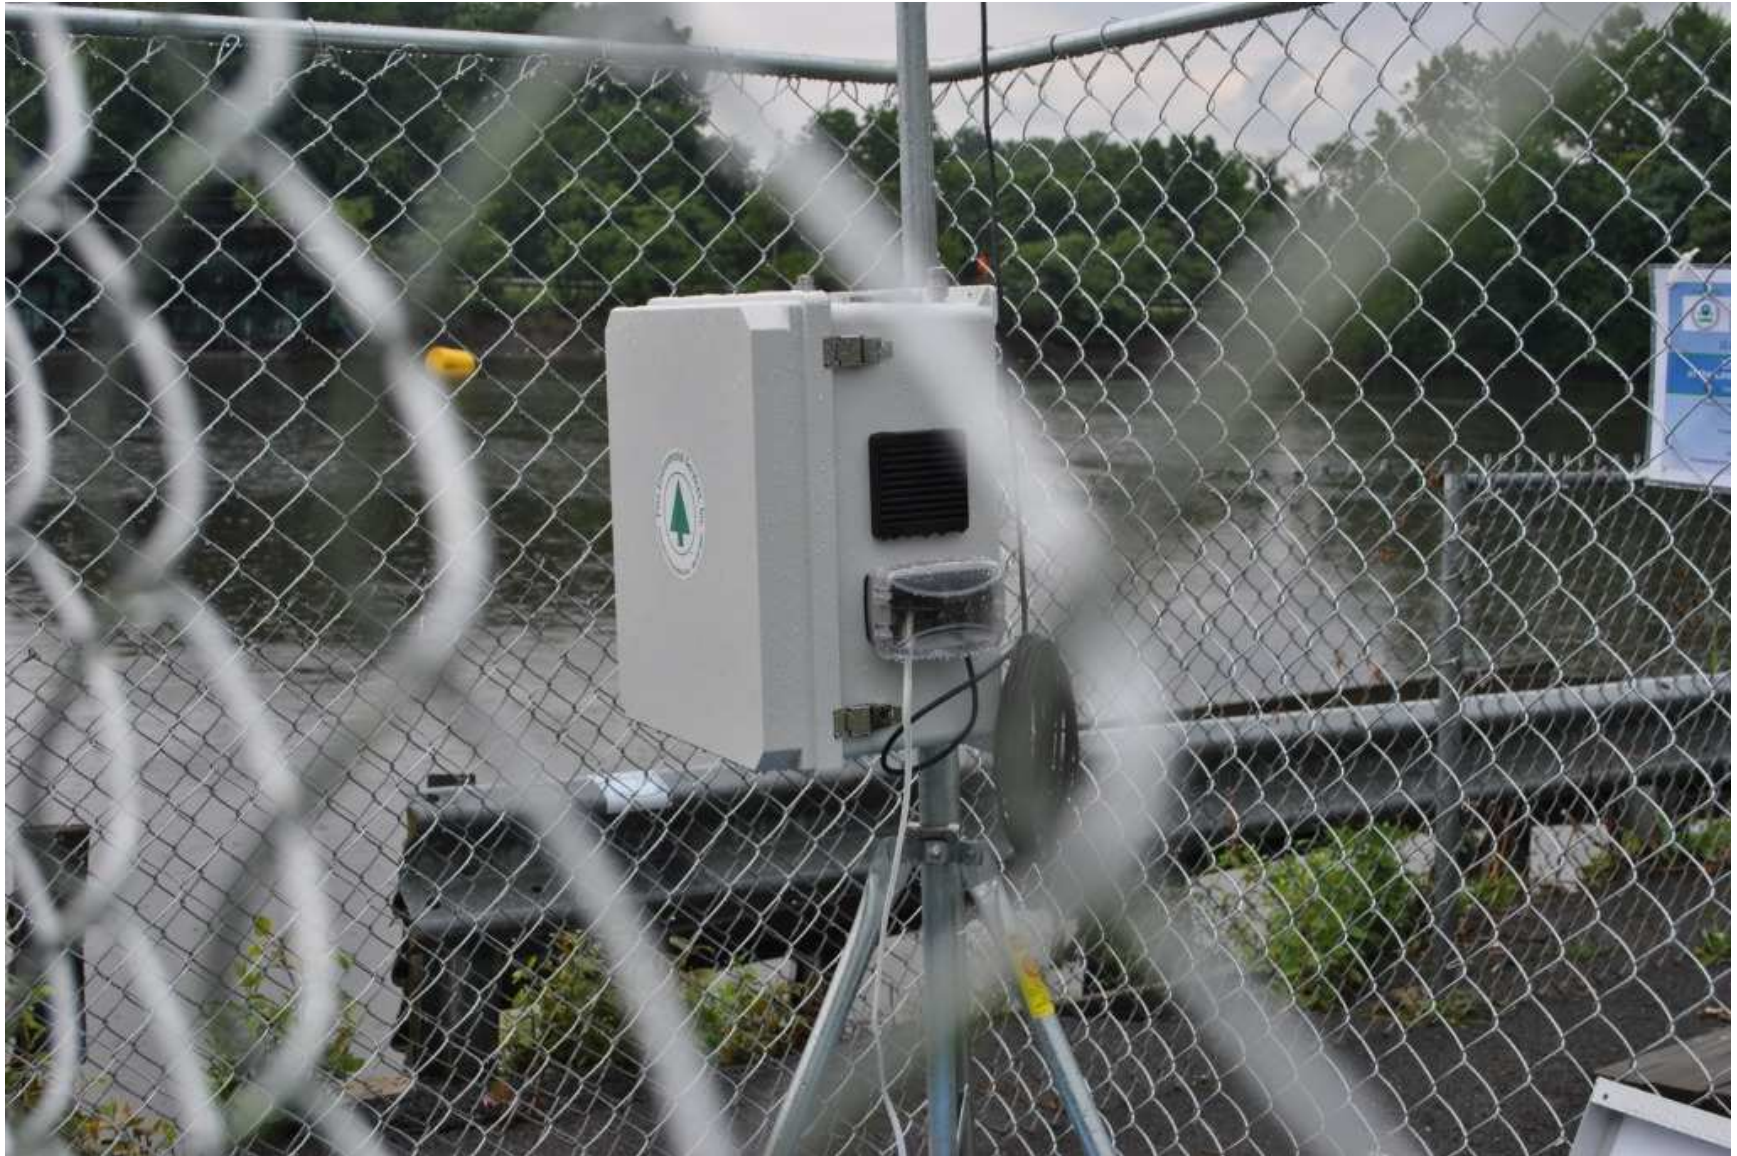
August 1 2013: Weather station

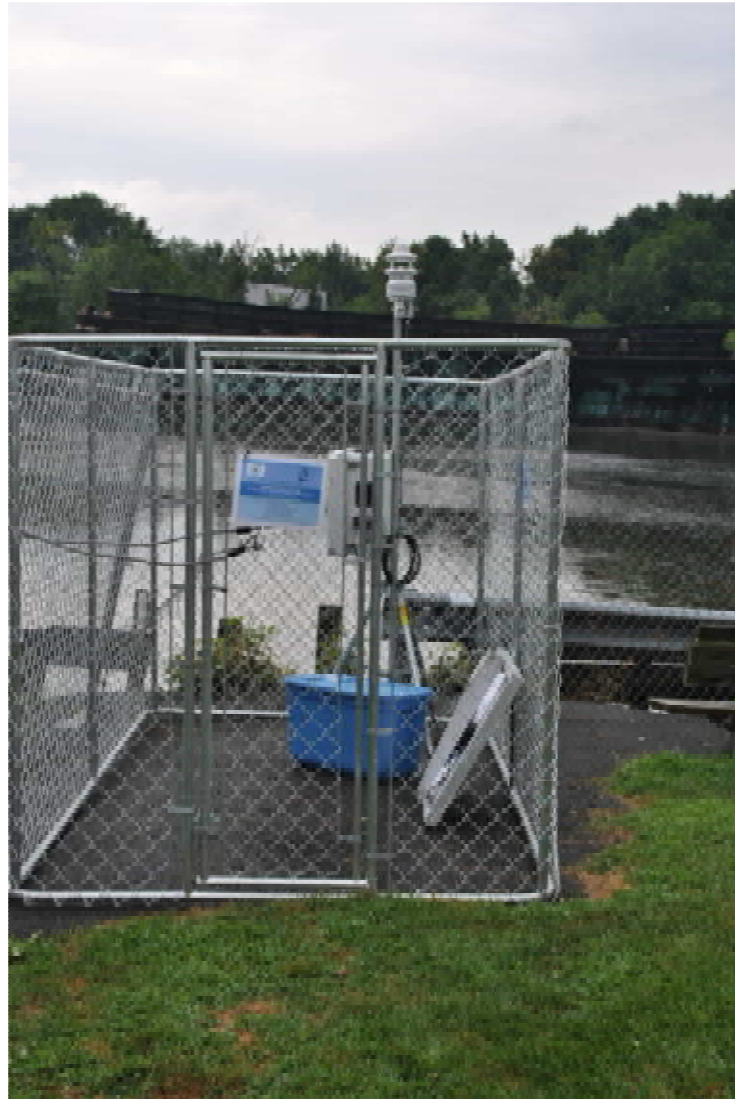
August 1 2013: Weather station

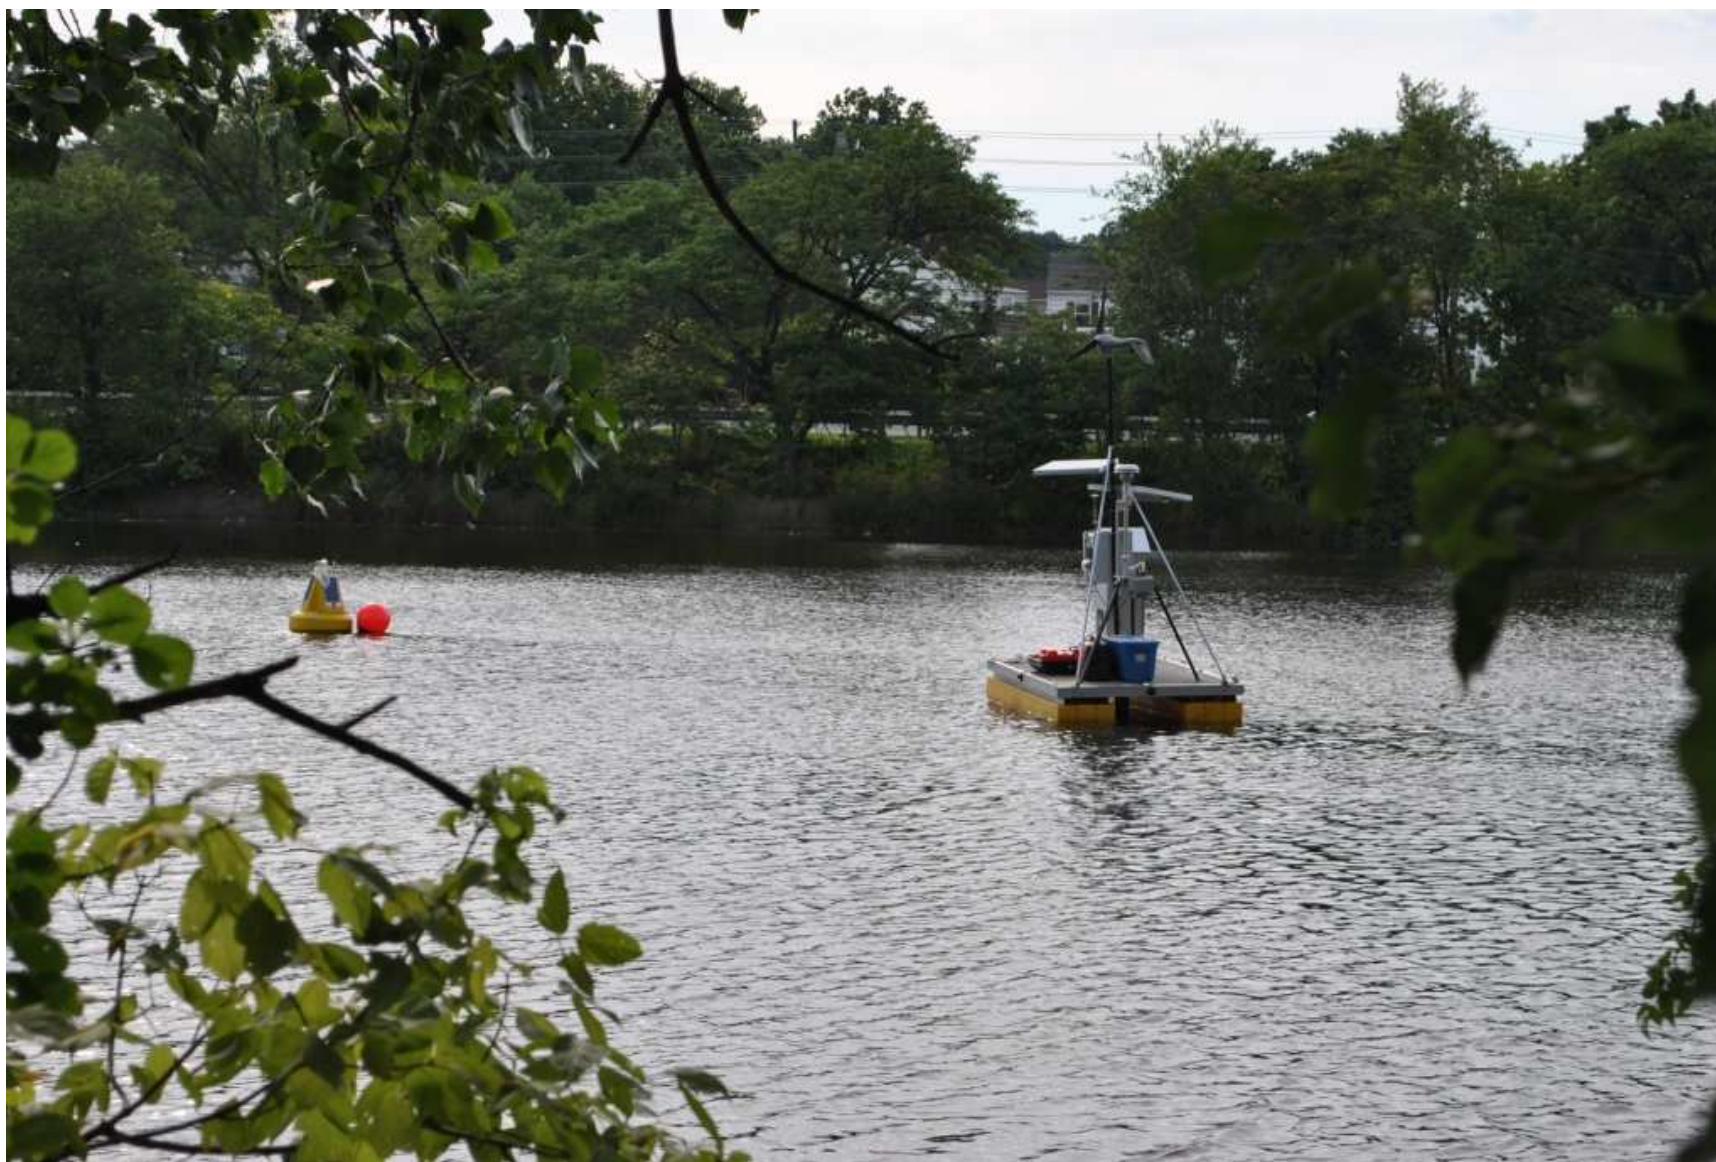
August 2 2013: In-river air monitor

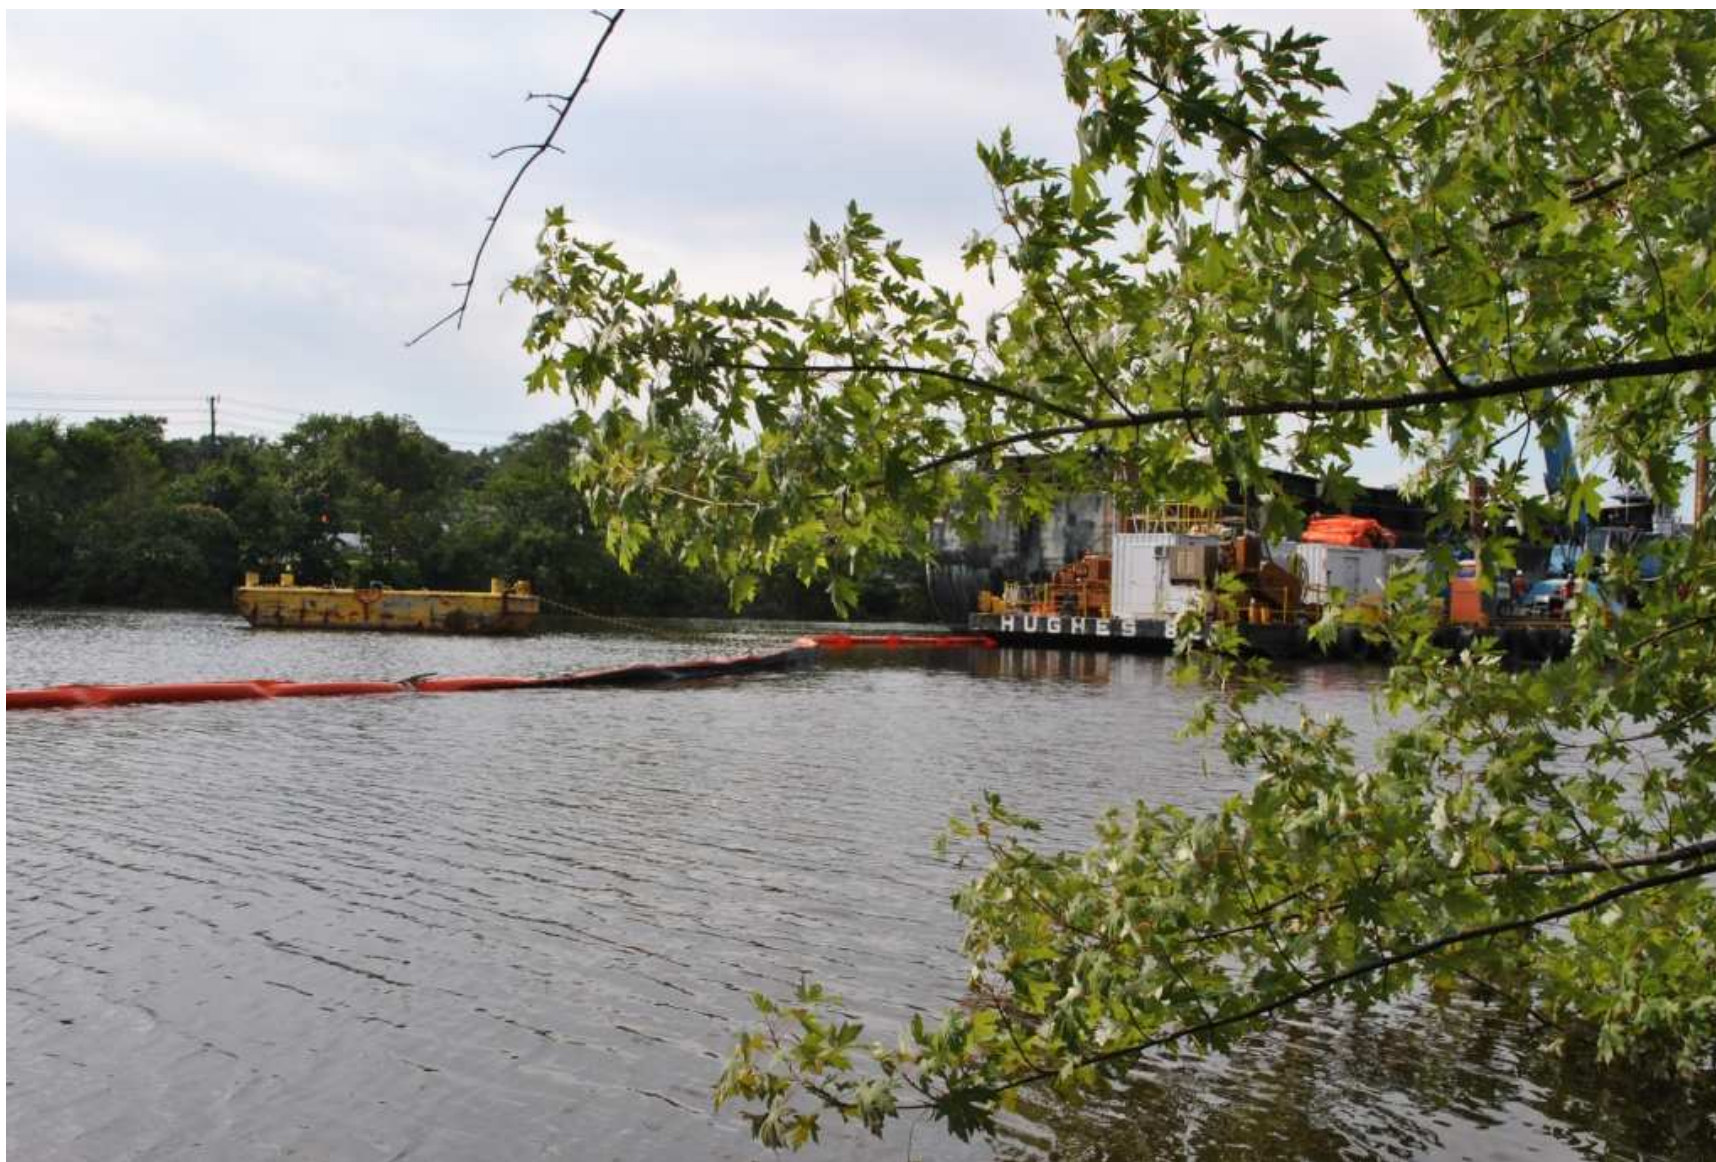
August 2 2013: Silt curtain anchored and unfurled
